FINAL TEST REPORT

Performance Mock-Up Testing Alpine LedgeGuard-Bar and LedgeGuard-12" System

Project # M18-23

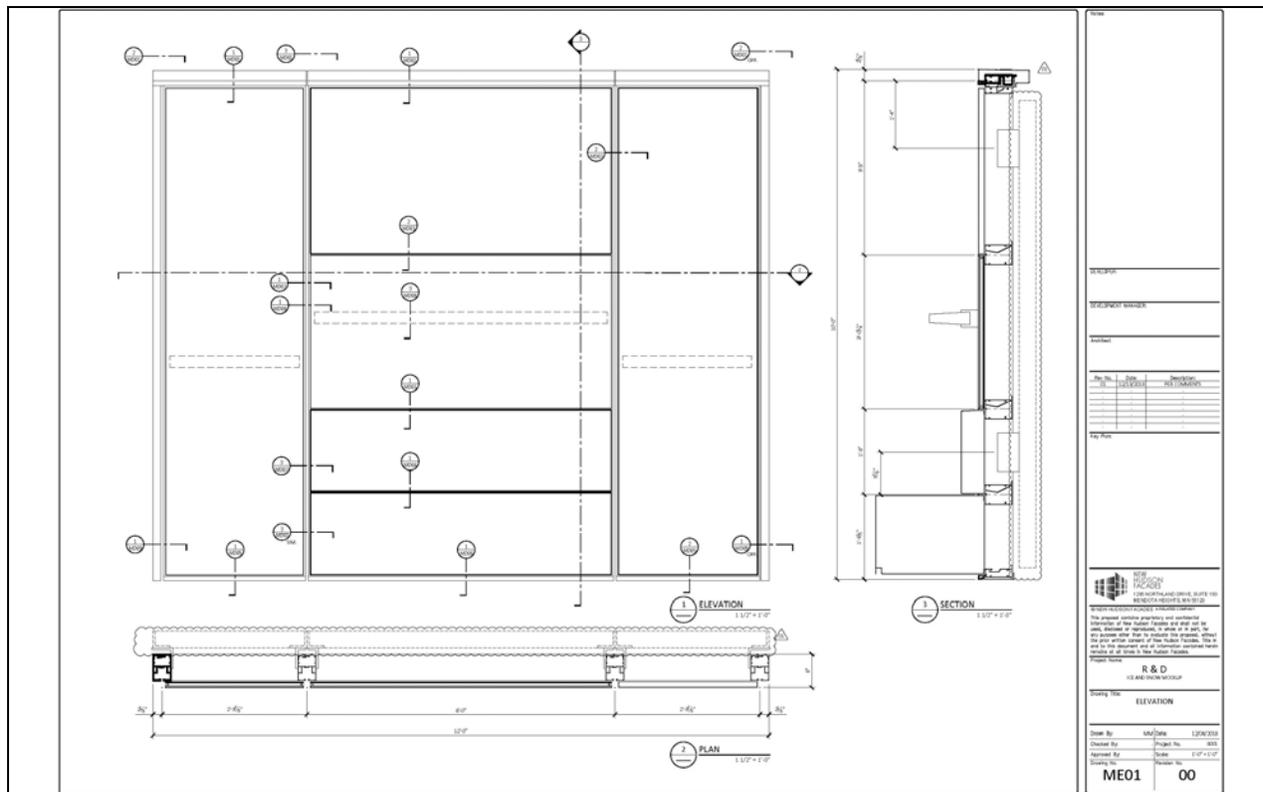
Figure 1 – New Hudson Facades Curtain Wall Design

As referred to previously, Figure 1 shows the curtain wall that was design and provided by New Hudson Facades to include typical materials, paint and glass properties of a high performance modern facade. The typical design geometries included in the facade design were:

- a large low sloped box-out ledge;
- a low slope window sill;
- a horizontal mullion with low slope sunshade; and,
- a wall parapet (note: the designed wall parapet cap was incomplete for testing and thus was not considered with the test results).

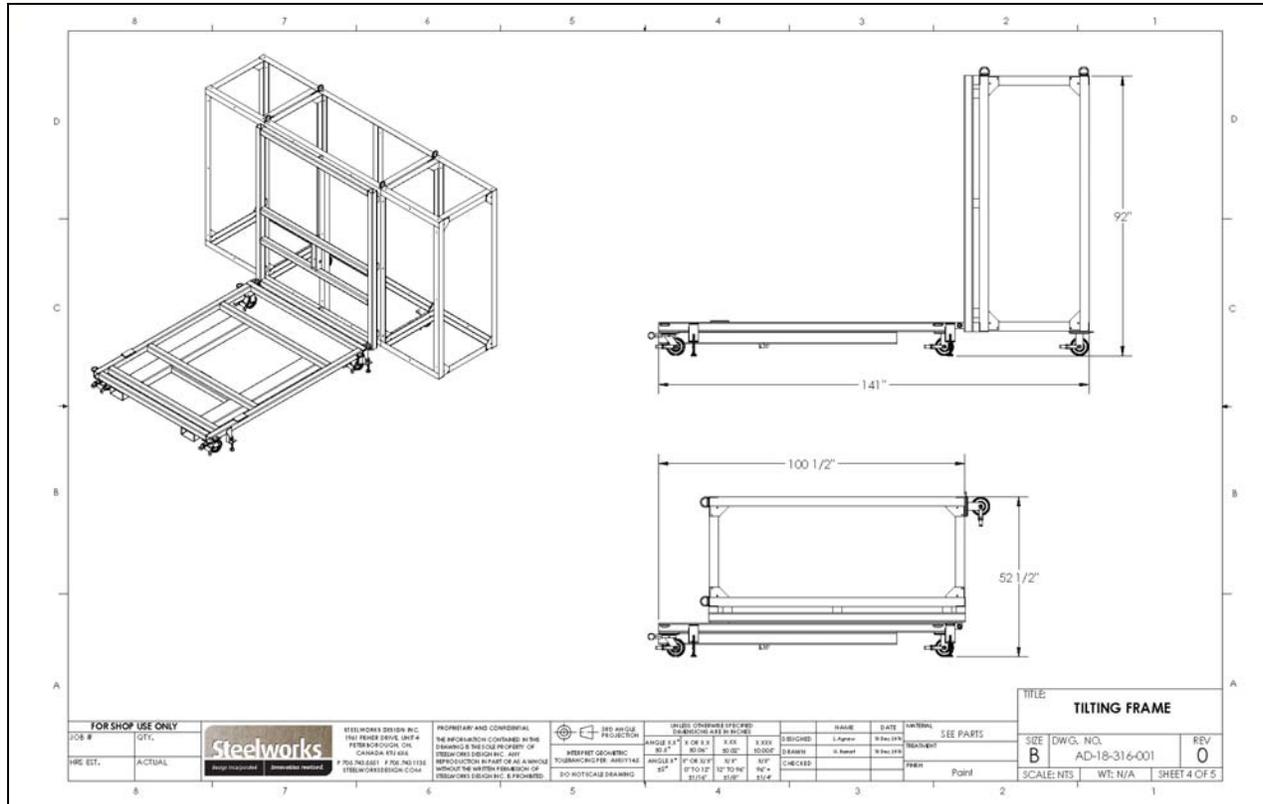
Figure 2 – Steelworks PMU Support Frame with Rear Heat Box

Figure 2 also shows the PMU Support Frame with the 4 foot deep thermally controlled heated box that was attached and sealed to the rear of the curtain wall to simulate appropriate facade skin temperatures. Once the support frame, heated box and curtain wall were assembled and installed in the LCC, the air temperature was lowered to 16°F (-9°C) and the PMU was left to acclimatize. A total of three (3) PMU configurations were planned and tested during a 3 day testing schedule. The completed test configurations included:

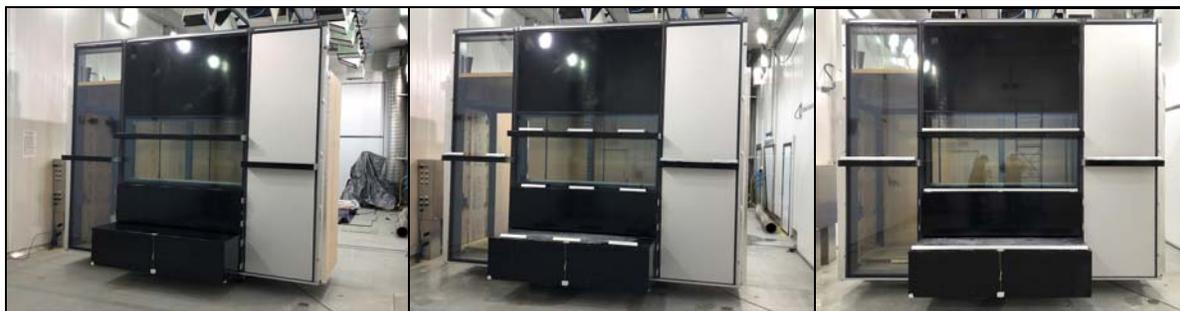
Figure 3 – Test #1
(No Ice and Snow Retention)
Figure 4 – Test #2
(LedgeGuard 12” @ 24” o.c.)
Figure 5 – Test #3
(LedgeGuard Continuous)

- Test #1 - Problem Condition (No Ice and Snow Retention Applied – refer to Figure 3)
- Test #2 – Alpine LedgeGuard-12 Inch (LedgeGuard 12” Applied at 24” O.C. – refer to Figure 4)
- Test #3 – Alpine LedgeGuard (LedgeGuard Applied Continuously – refer to Figure 5)

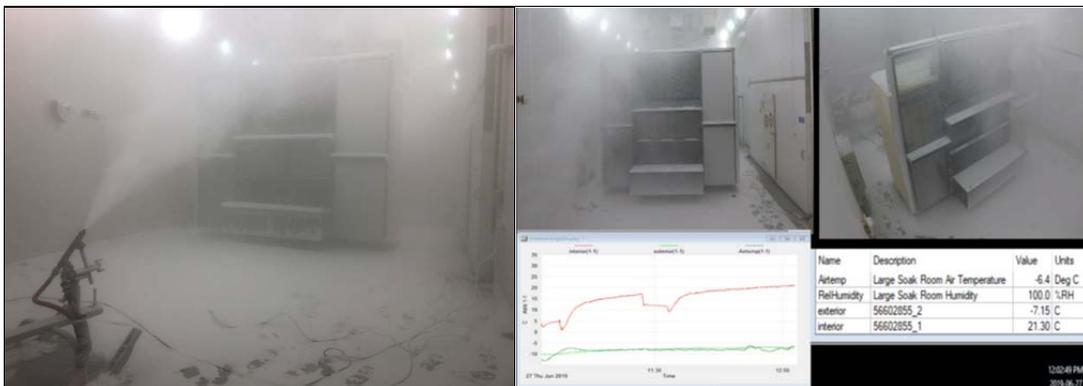
Figure 6 – Snow Making

Figure 7 – Example of Test Data

Once the test chamber and PMU had acclimatized snowfall was produced within the test chamber by a snow gun calibrated and positioned appropriately to produce an application of wet heavy snow on all curtain wall surfaces (refer to Figure 6). To produce snow pressurized water and air are expelled from the snow gun, mixing and traveling in an arc trajectory ultimately travelling in a downward angle toward the curtain wall, simulating windblown snowfall. The maximum snow depths for each test were achieved through 3 separate snow making applications separated by time periods required for equipment defrost cycles. Each test configuration was documented through both digital and manual measurements as well as video recording and still photography (refer to Figure 7).

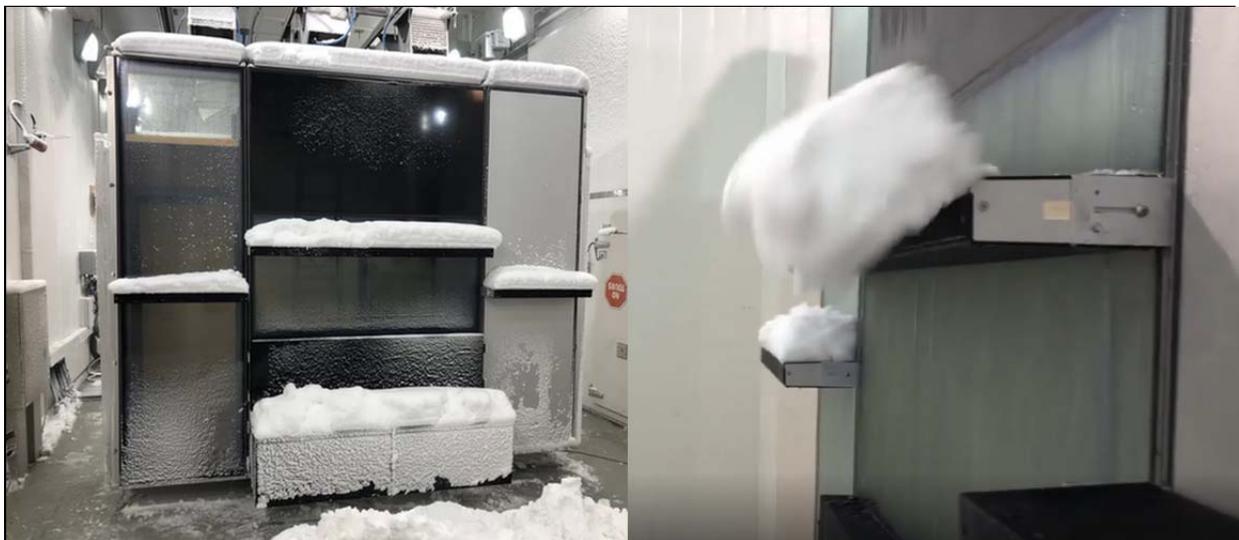
Figure 8 – Test #1
Accumulated Ice and Snow

Figure 9 – Test #1
Falling Ice and Snow

- After 3 applications of snow within the climatic test chamber, the low sloped surfaces of the curtain wall facade collected 7 to 10 Inches of wet heavy snow (refer to Figure 8).

- Once snow production was complete and air temperatures were raised above 32°F (0°C) within the climatic test chamber, melt water produced within the collected snow migrated downward, saturating the frozen connection of snow to the low sloped metal surfaces. As a result, shortly after melting began, masses of snow started to release, slide and fall from the low sloped surfaces, creating a potential hazard for people and property that exists below (refer to Figures 9, 10 and 11).

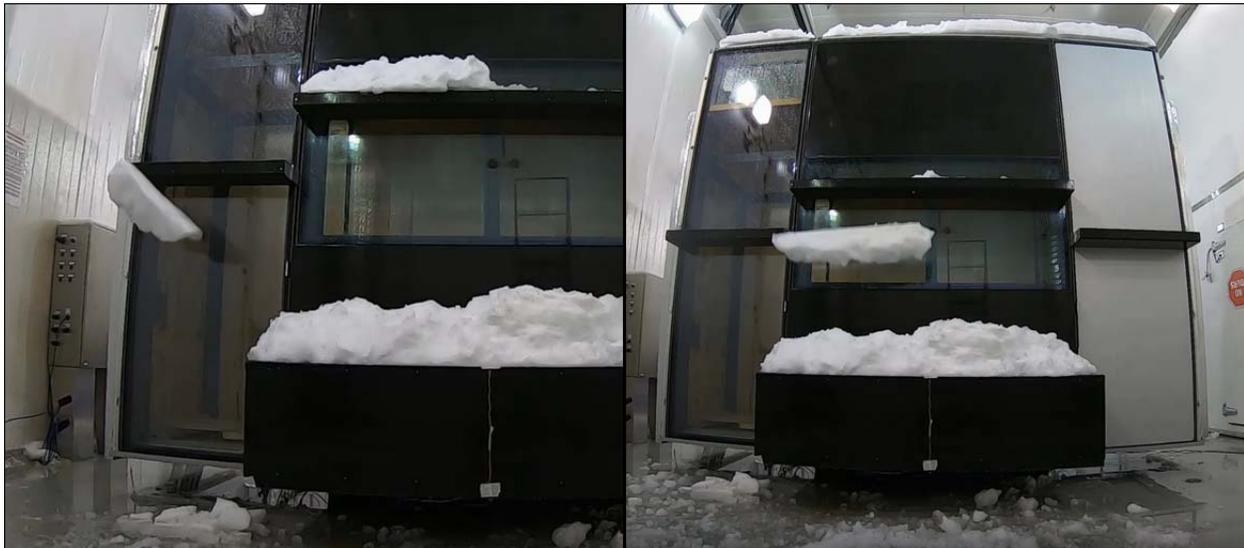
Figure 10 – Test #1
Falling Ice and Snow

Figure 11 – Test #1
Falling Ice and Snow

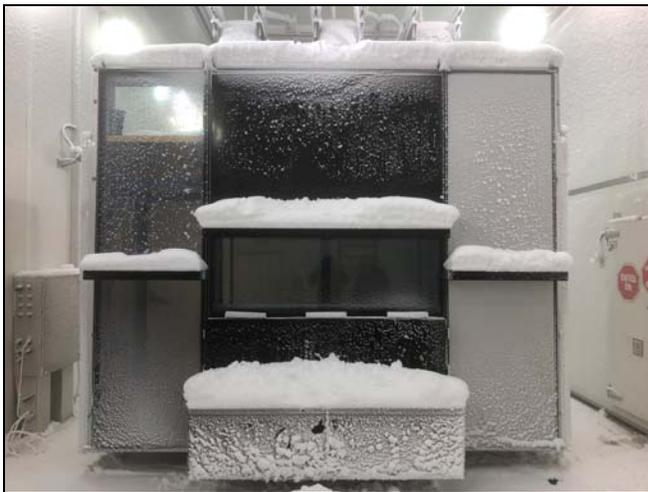
Figure 12 – Test #2
Accumulated Ice and Snow

- Similar to Test #1, after 3 applications of snow within the climatic test chamber, the low sloped surfaces of the curtain wall facade collected 7 to 10 inches of wet heavy snow (Ledges, sills, horizontal mullions or sun shades – refer to Figures 12 and 14).

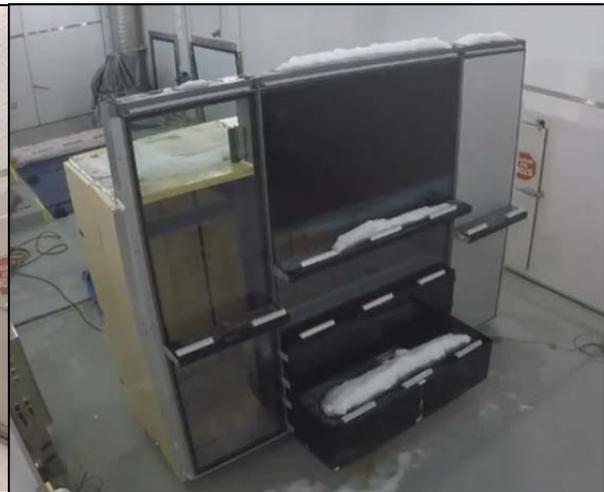
Figure 13 – Test #2
Ice and Snow Melting in Place

- However, different than Test #1, in both Test #2 and Test #3, snow that collected behind the LedgeGuard system products (i.e. ice and snow barriers) experienced resistance to movement and therefore did not release and fall from the low sloped surfaces, significantly reducing the potential of a falling ice and snow hazard for people and property that exists below (refer to Figures 13 and 15).

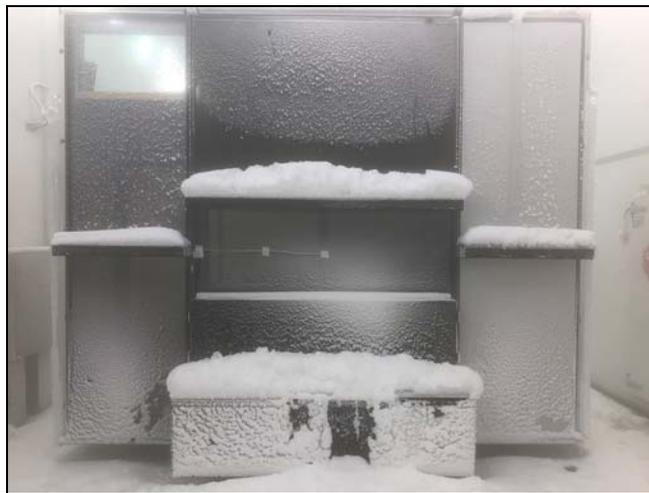
Figure 14 – Test #3
Accumulated Ice and Snow

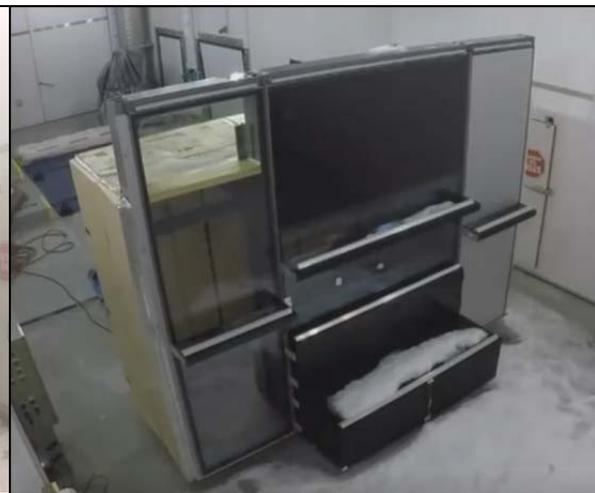
Figure 15 – Test #3
Ice and Snow Melting in Place
